Upgrading/ Improvement of Roadside Slope/
Retaining Walls on Hong Kong Island (2005-
2008 Programme) – Investigation, Design and
Construction

Heritage Impact Assessment Report for Feature No. 11SW-B/R93 (Sub- division 1), Duddell Street

Report Ref: M45/200

Final | June 2013

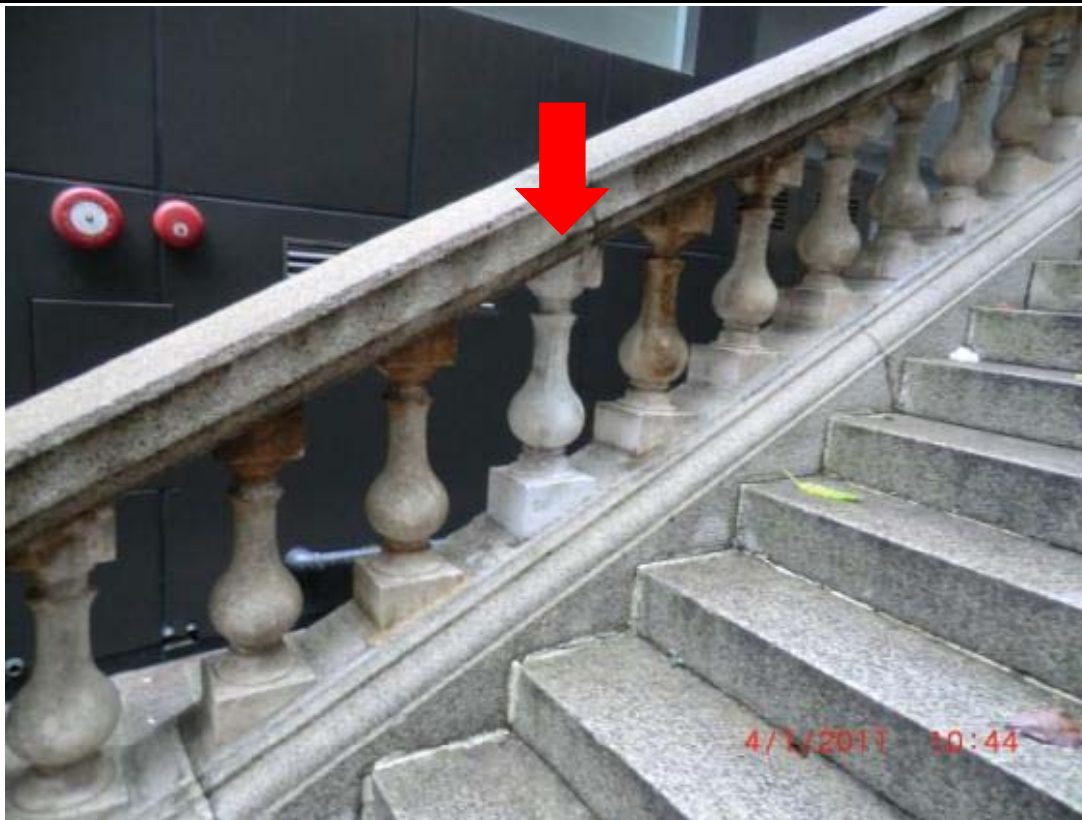
Subject Granite Stone Handrailing (Plate 21) **Date photograph taken** 04-Jan-11

Description View showing the reinstatement works carried out for one of the balusters

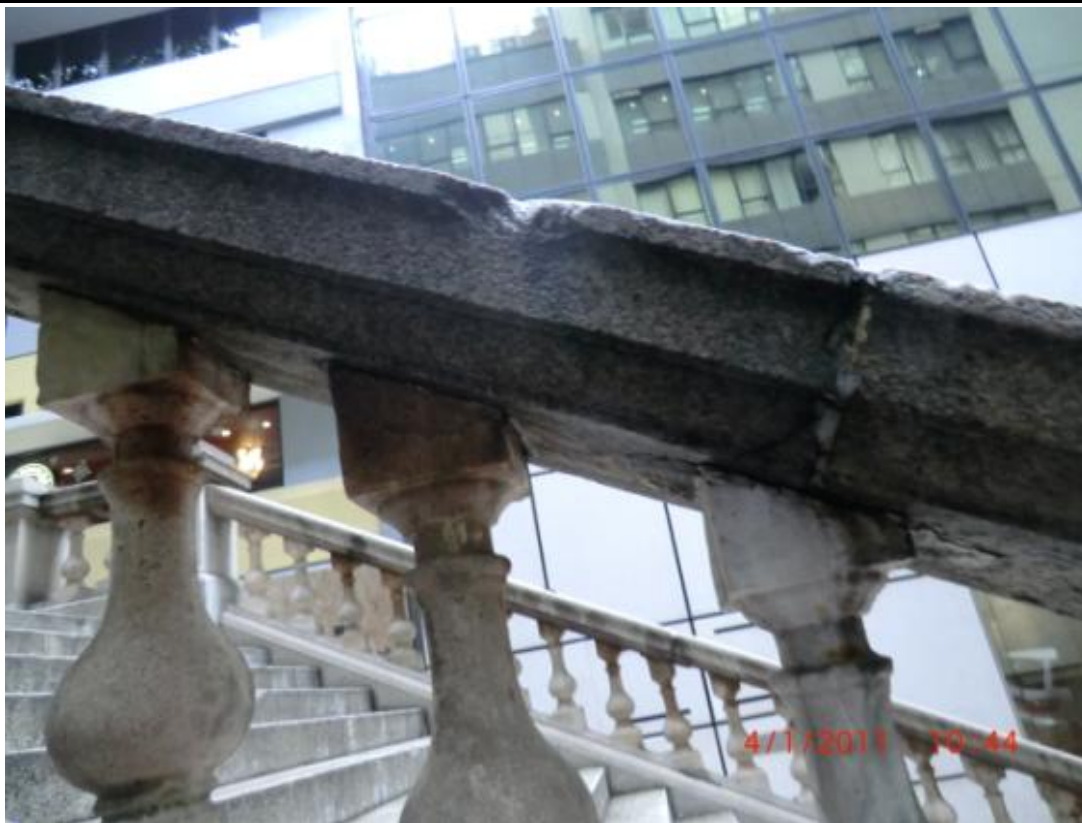
Subject Granite Stone Handrailing (Plate 24) **Date photograph taken** 04-Jan-11

Description Part of the handrailings are damaged prior to the commencement of the Works

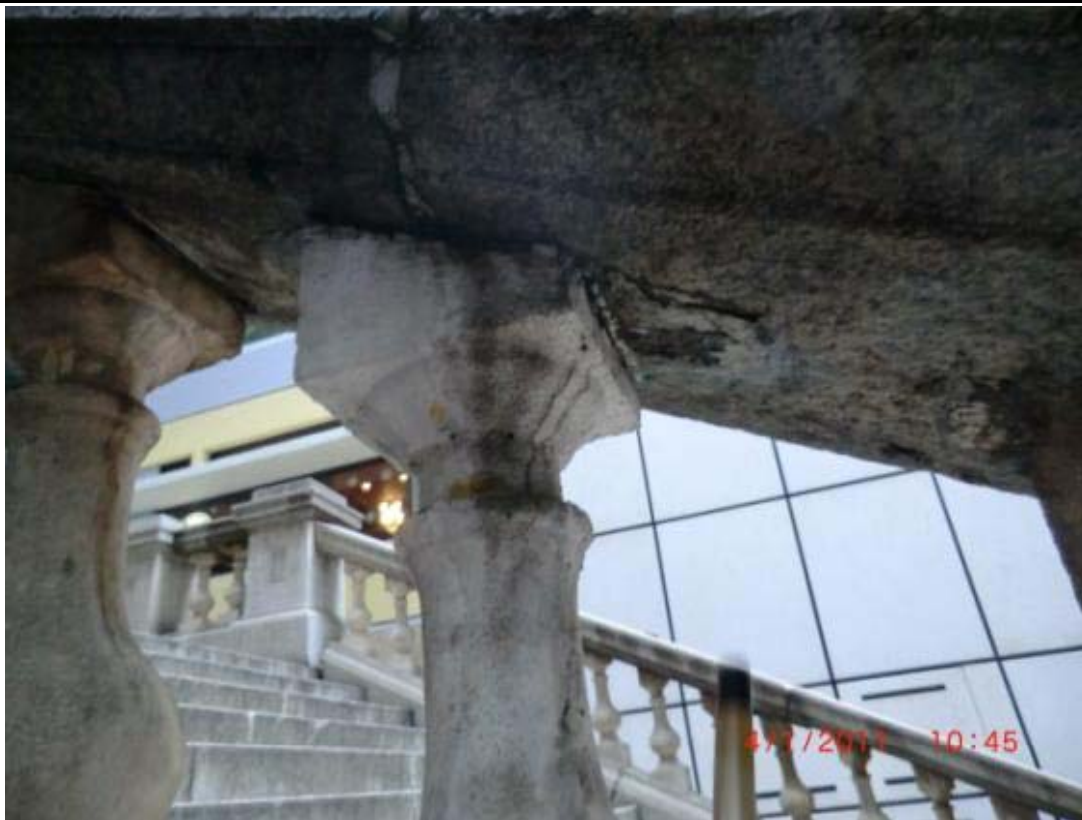
Subject Granite Stone Handrailing (Plate 25) **Date photograph taken** 04-Jan-11

Description View showing the reinstated baluster

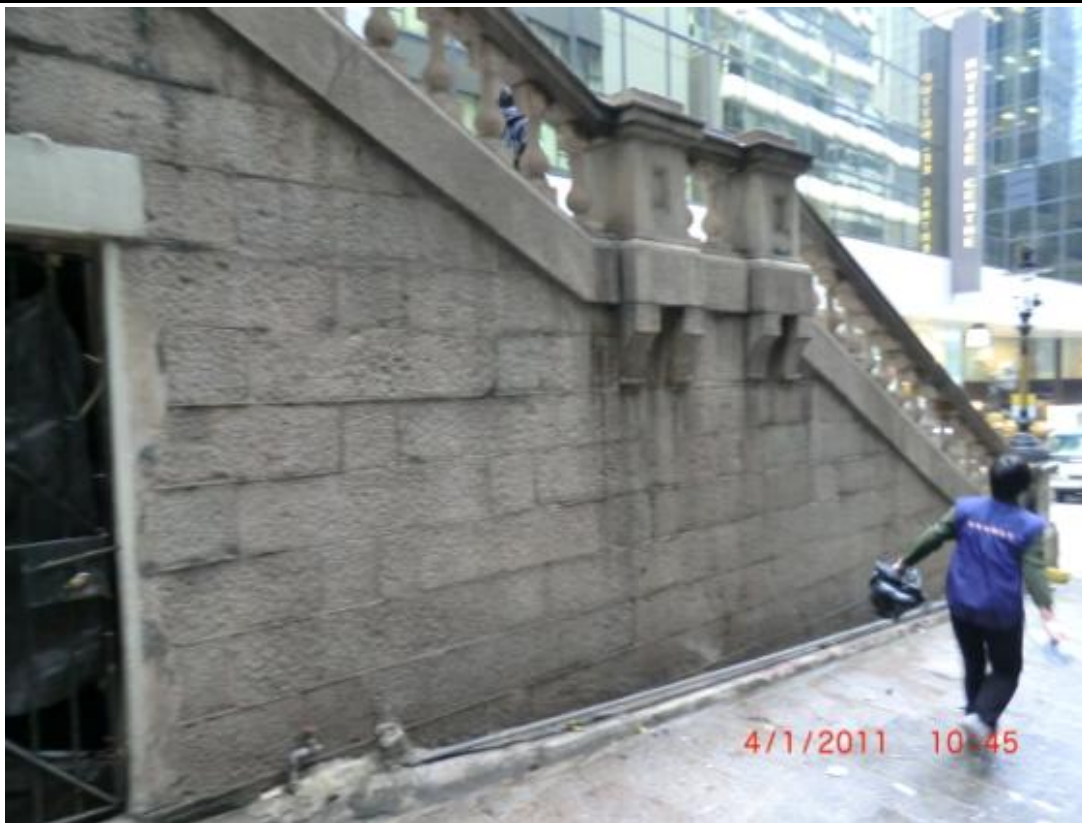
Subject Granite Stone Facing (Plate 30) **Date photograph taken** 04-Jan-11

Description View showing the existing condition of masonry facing of the declared monuments

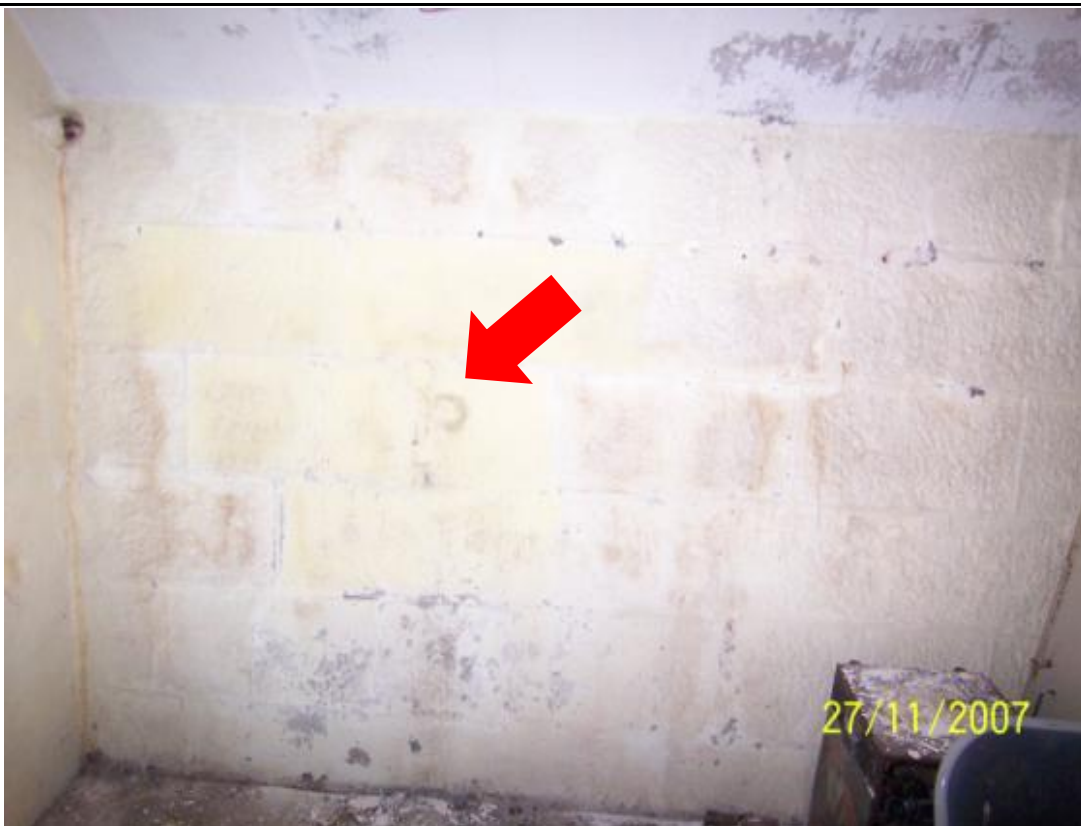
Subject Storeroom with arch ceiling (Plate 34) **Date photograph taken** 27-Nov-09

Description Some traces of screwholes and coreholes are left on the surface of the wall

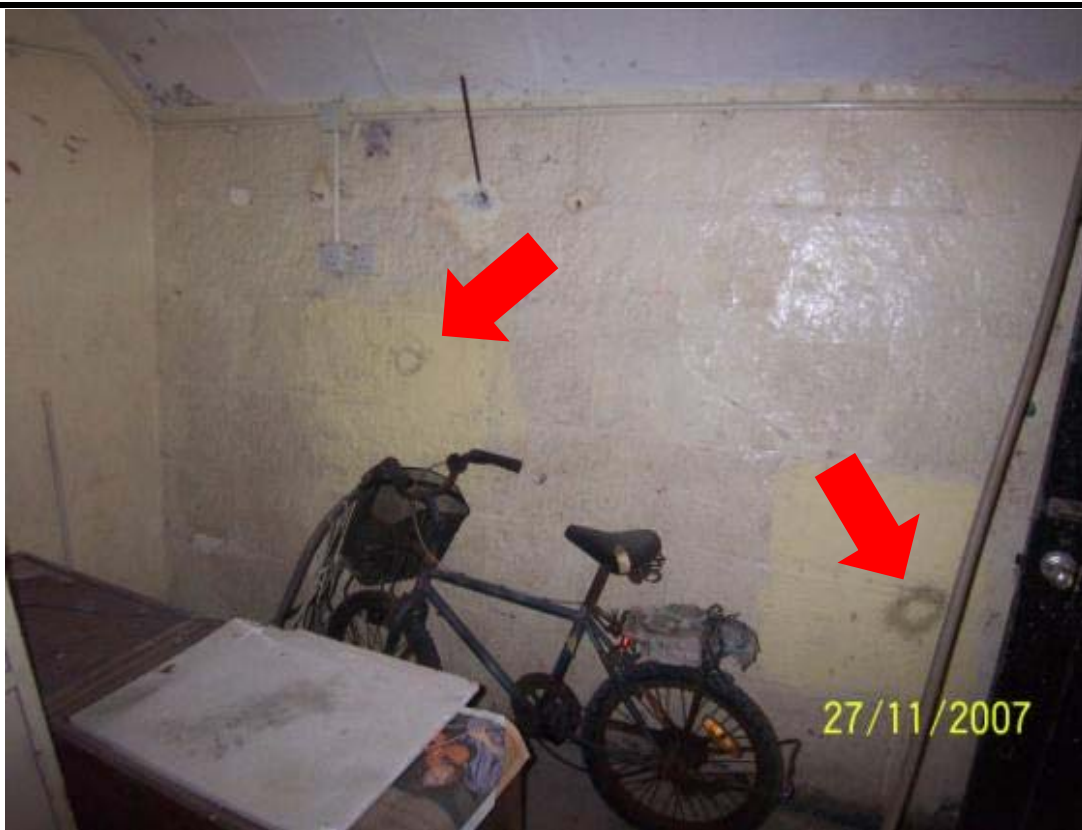
Subject Storeroom with arch ceiling (Plate 35) **Date photograph taken** 27-Nov-09

Description Some traces of screwholes and coreholes are left on the surface of the wall

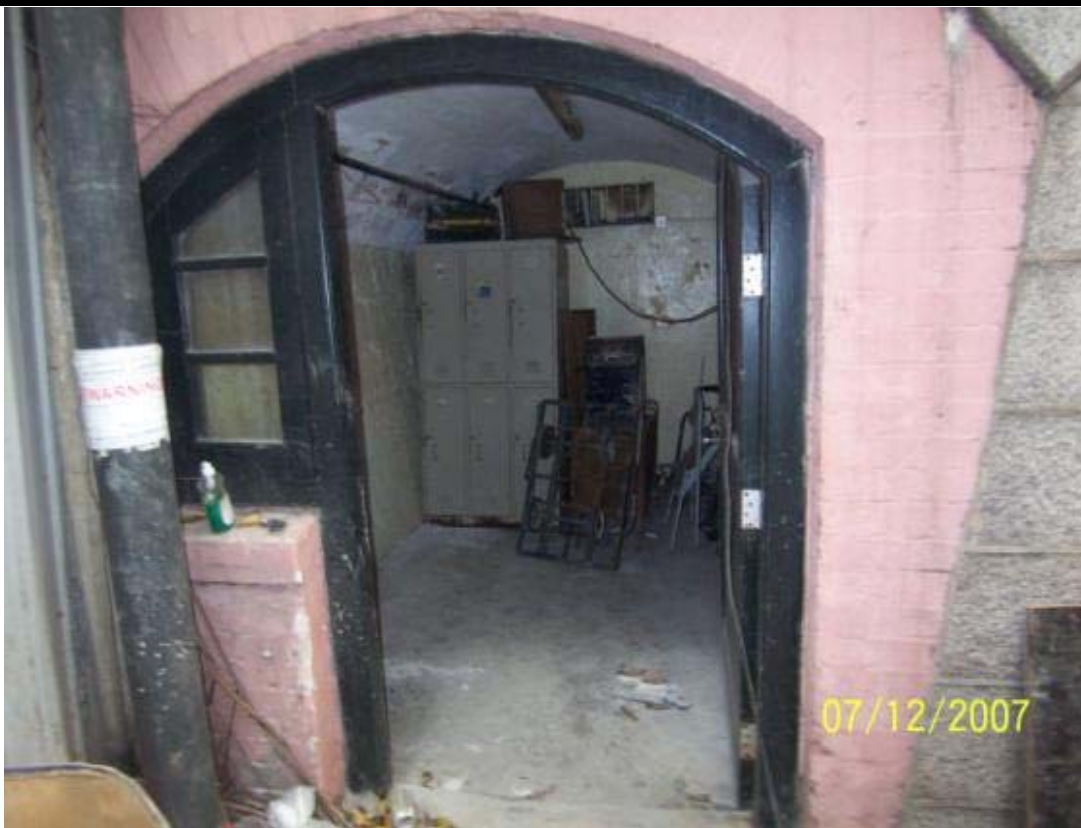
Subject Storeroom with arch ceiling (Plate 37) **Date photograph taken** 07-Dec-07

Description The condition of the wooden door and glass window is considered fair

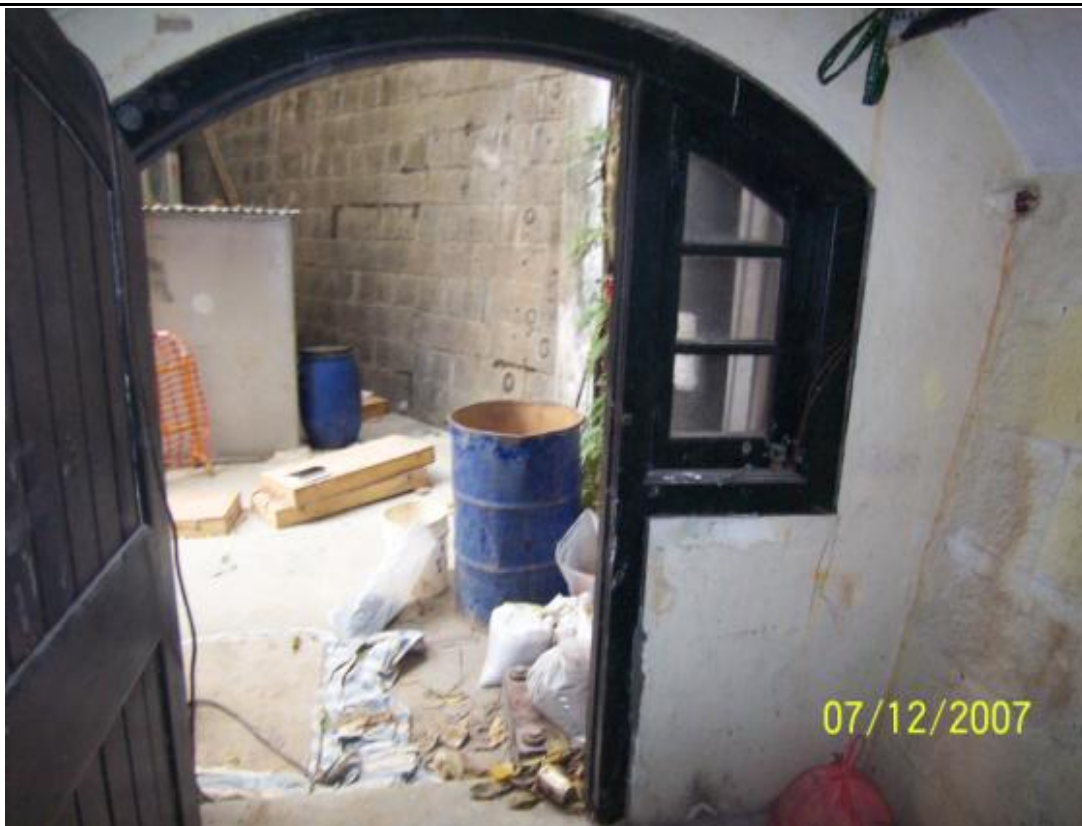
Subject Storeroom with arch ceiling (Plate 40) **Date photograph taken** 07-Dec-07

Description The condition of the wooden door and glass window is considered fair

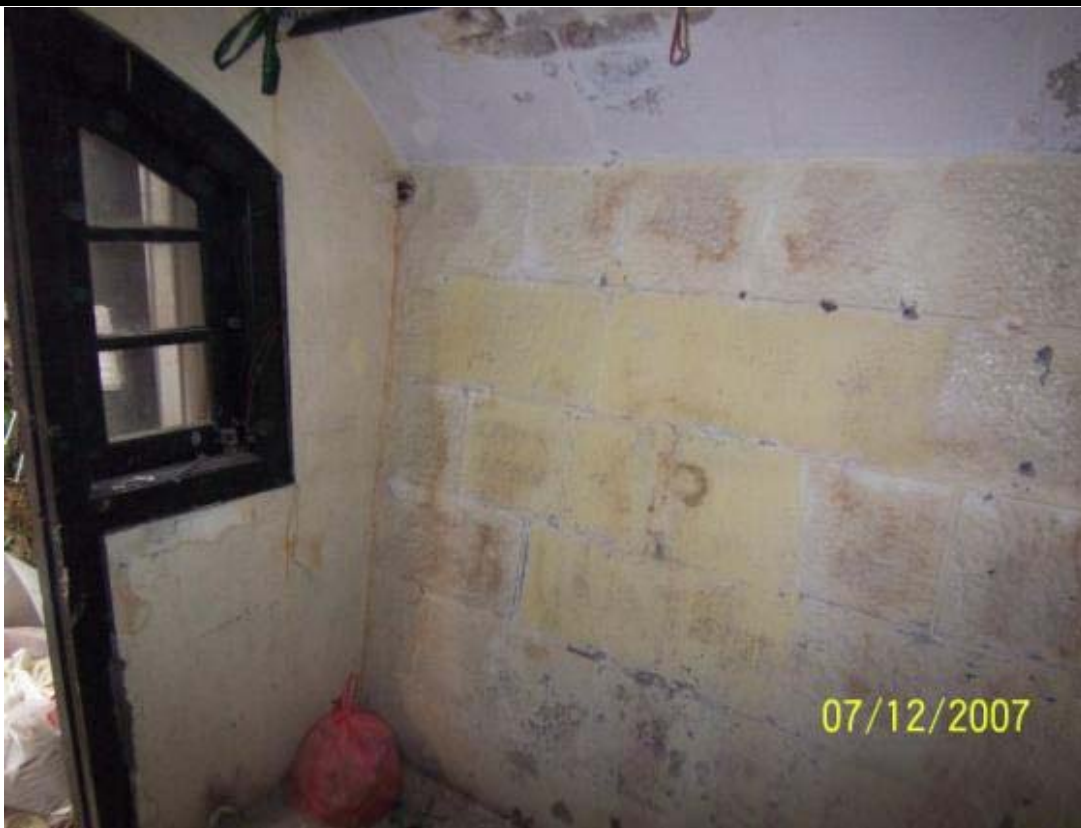
Subject Storeroom with arch ceiling (Plate 41) **Date photograph taken** 07-Dec-07

Description The ceiling plaster is peeling off

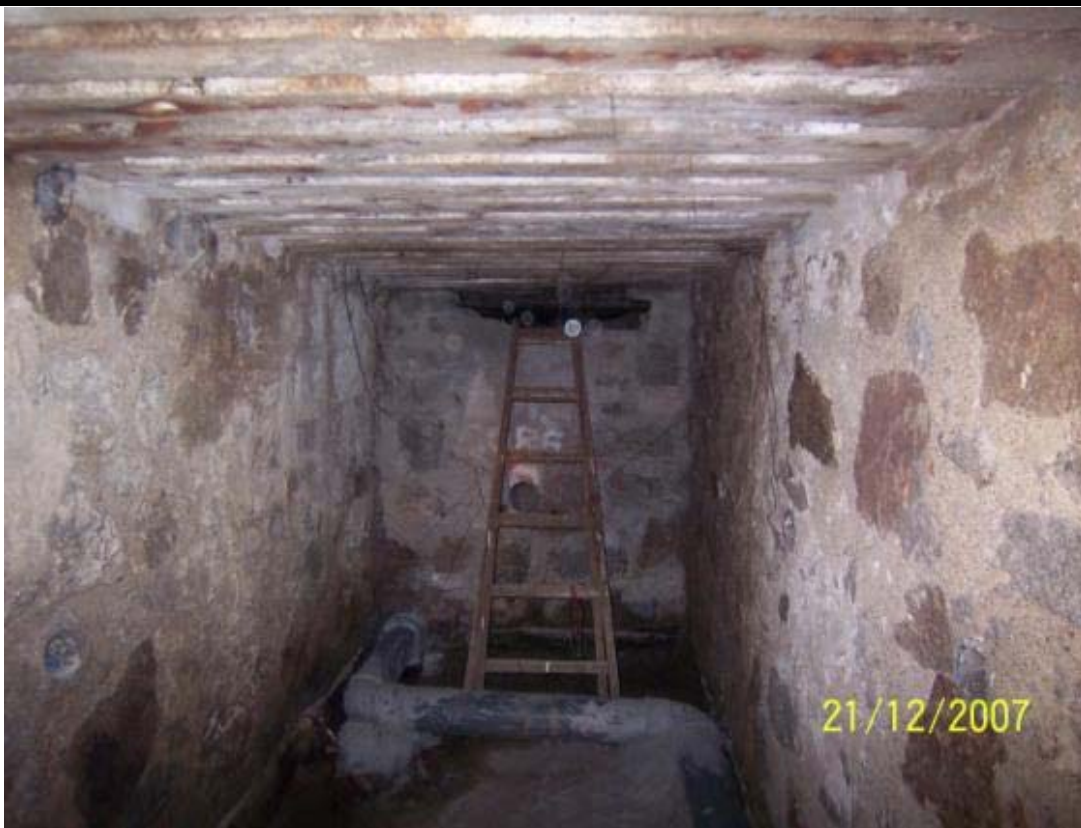
Subject Disused tunnel connected to Portal 43 (Plate 45) **Date photograph taken** 21-Dec-07

Description A wooden ladder is leaning against the back of the tunnel

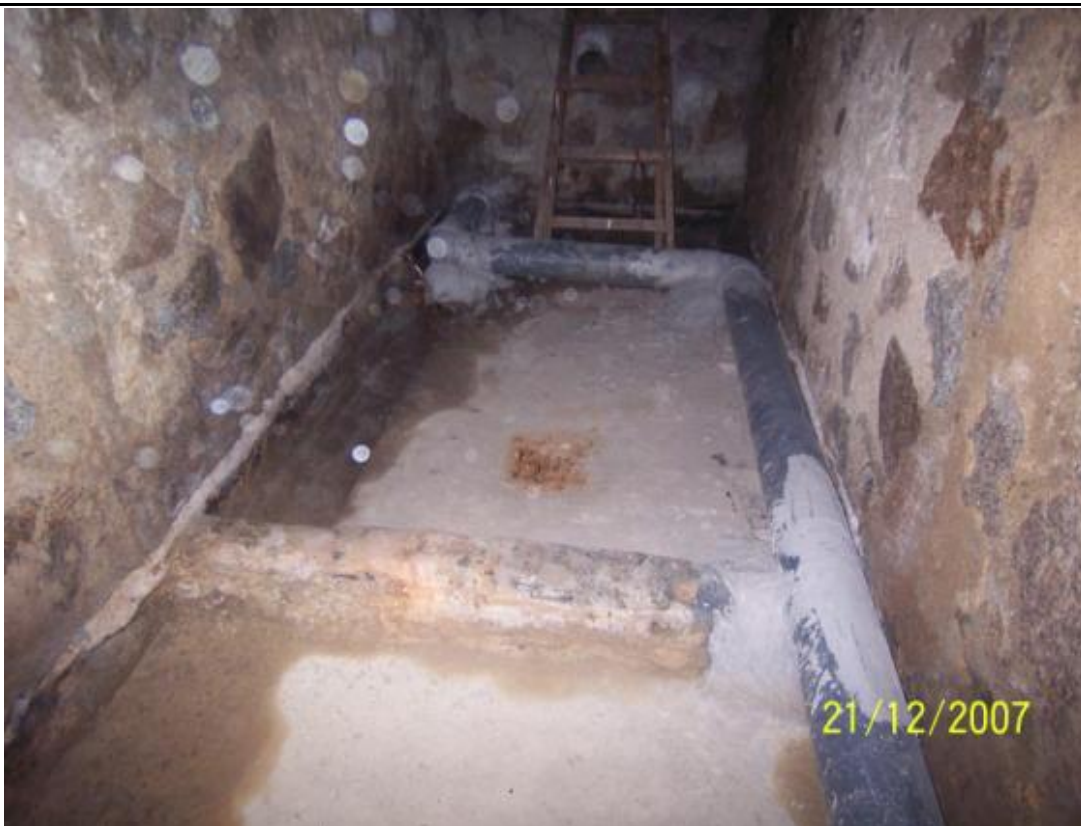
Subject Disused tunnel connected to Portal 43 (Plate 46) **Date photograph taken** 21-Dec-07

Description Seepage is observed from the masonry sidewalls

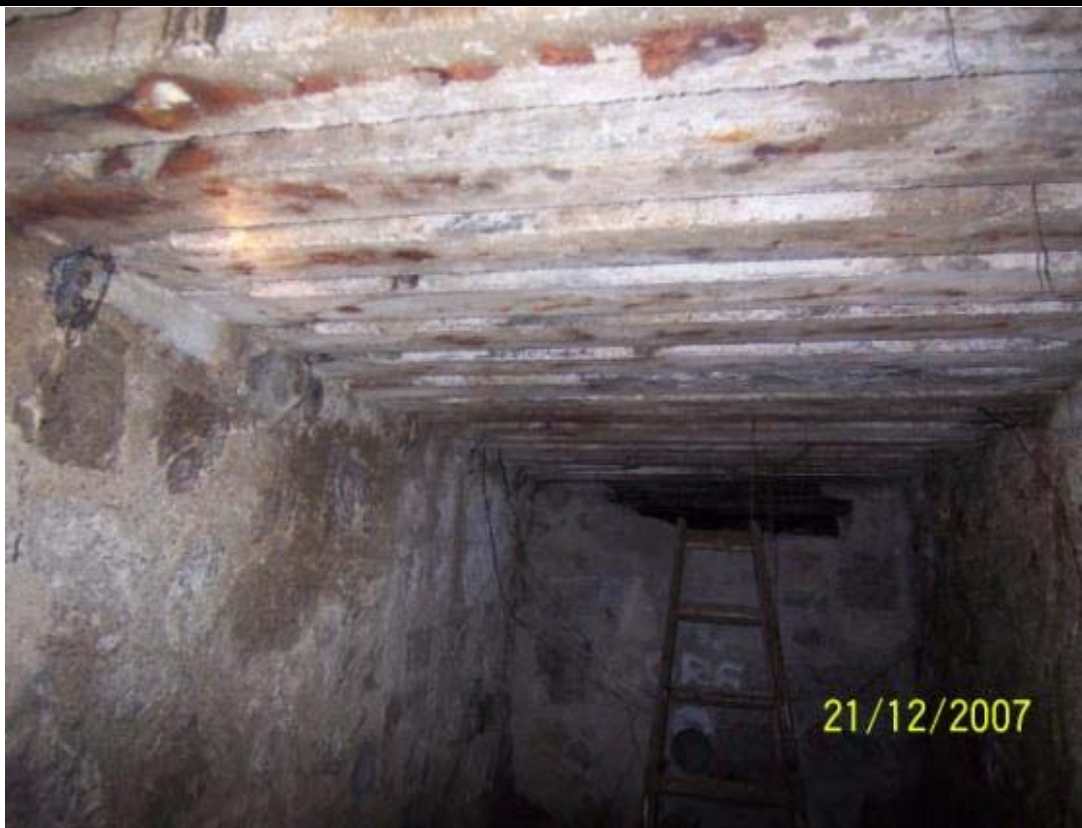
Subject Disused tunnel connected to Portal 43 (Plate 47) **Date photograph taken** 21-Dec-07

Description Row of flat precast reinforced concrete lintels is observed at the ceiling

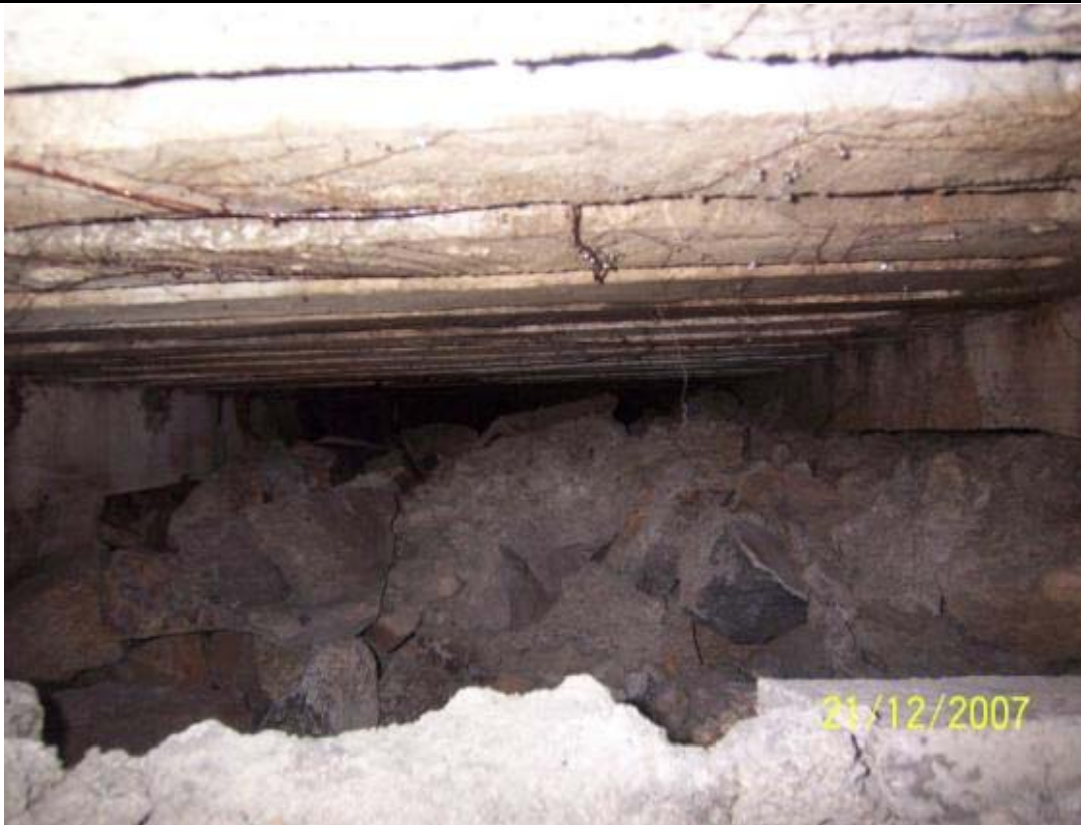
Subject Disused tunnel connected to Portal 43 (Plate 49) **Date photograph taken** 21-Dec-07

Description Behind the backwall, the tunnel is filled with boulders and cement

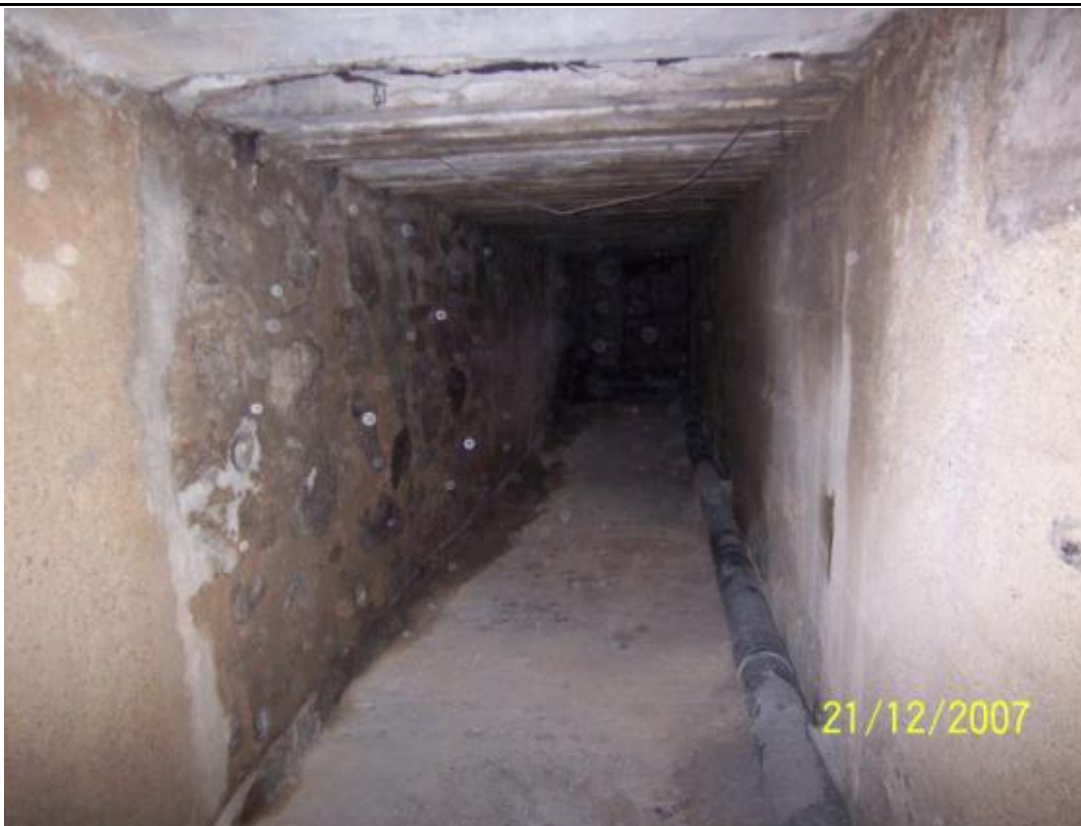
Subject Disused tunnel connected to Portal 43 (Plate 50) **Date photograph taken** 21-Dec-07

Description The general condition of the tunnel is fair

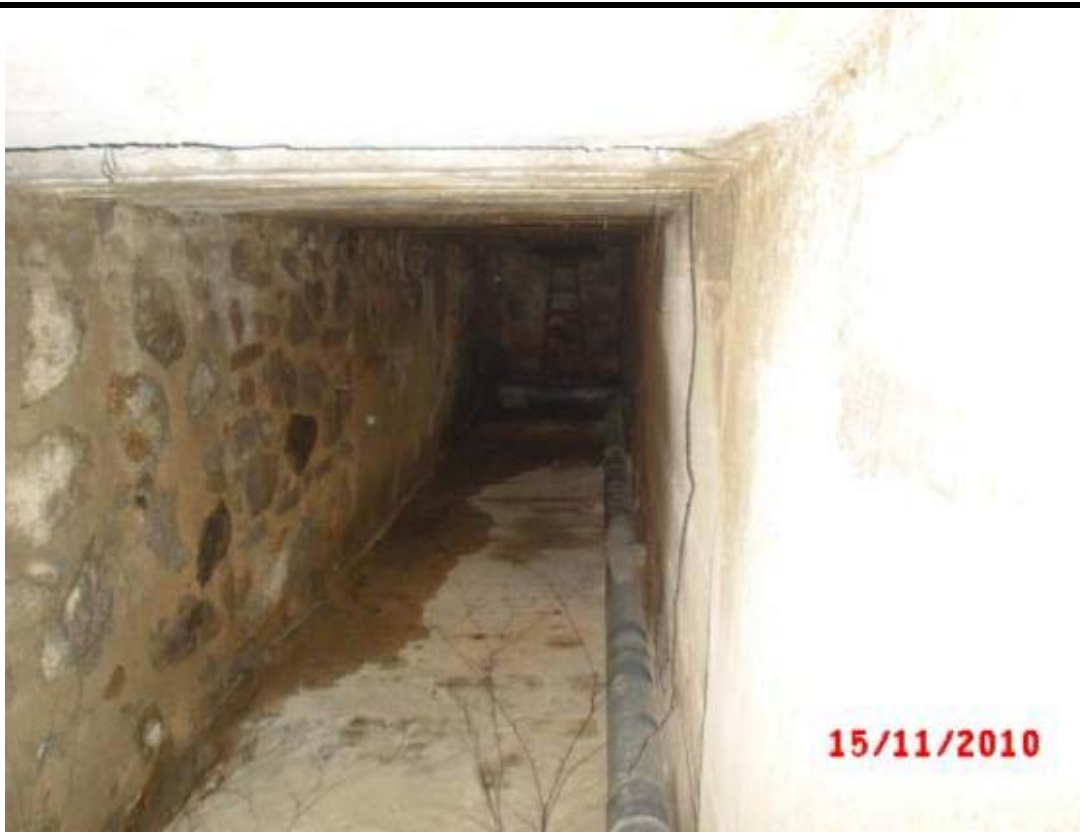
Subject Disused tunnel connected to Portal 43 (Plate 51) **Date photograph taken** 15-Nov-10

Description Tree roots are observed inside the tunnel

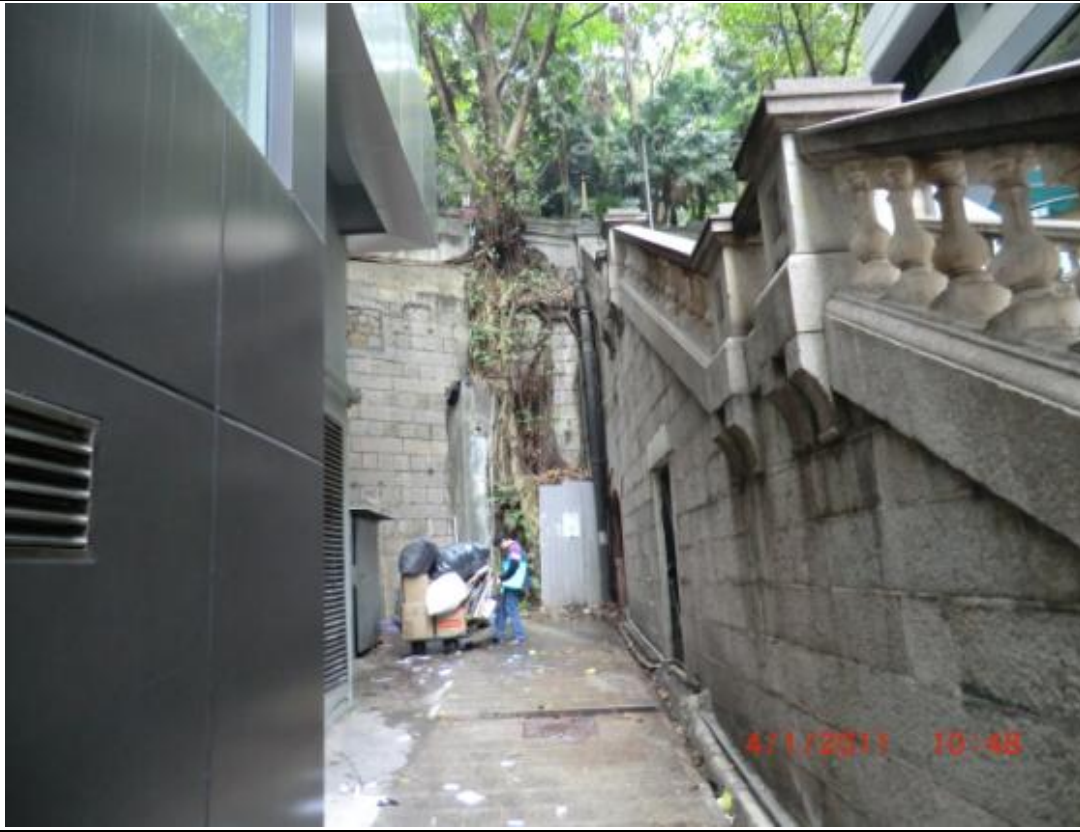
Subject Disused tunnel connected to Portal 44 (Plate 52) **Date photograph taken** 04-Jan-11

Description General view of Portal 44

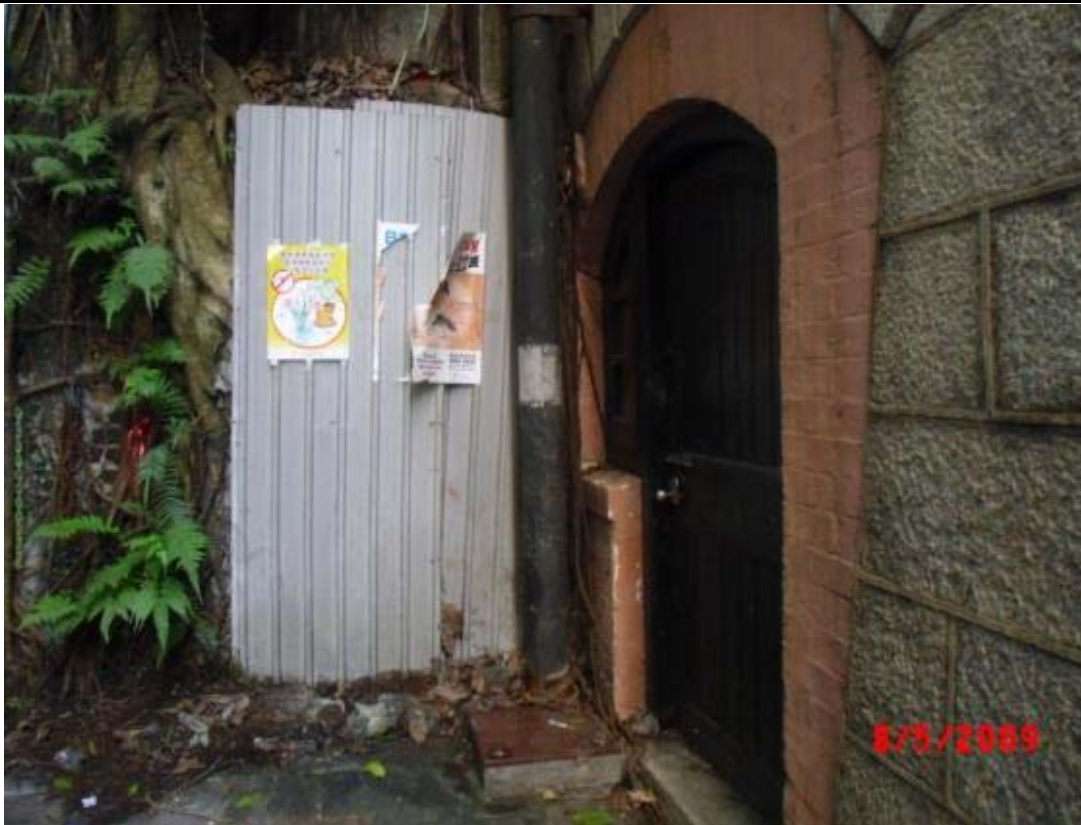
Subject Disused tunnel connected to Portal 44 (Plate 53) **Date photograph taken** 08-May-09

Description The entrance of Portal 44 is covered by corrugated steel plates

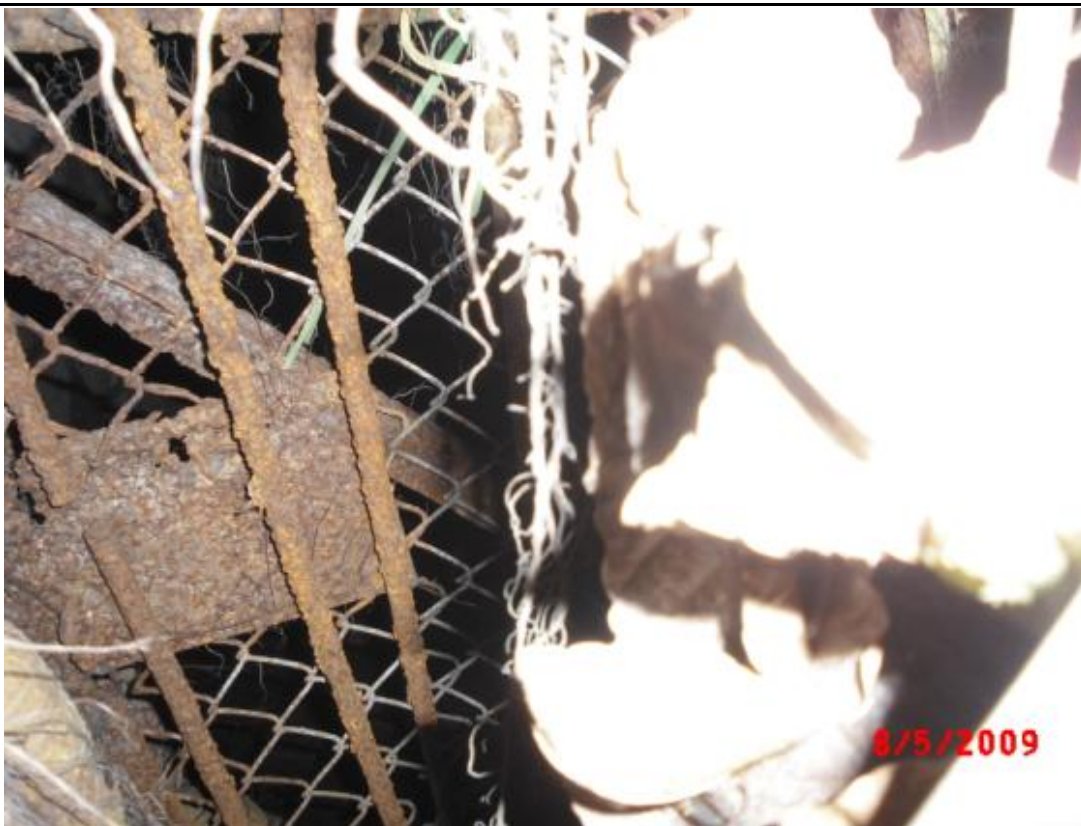
Subject Disused tunnel connected to Portal 44 (Plate 54) **Date photograph taken** 08-May-09

Description Behind the steel plate, the tunnel is locked by a steel gate

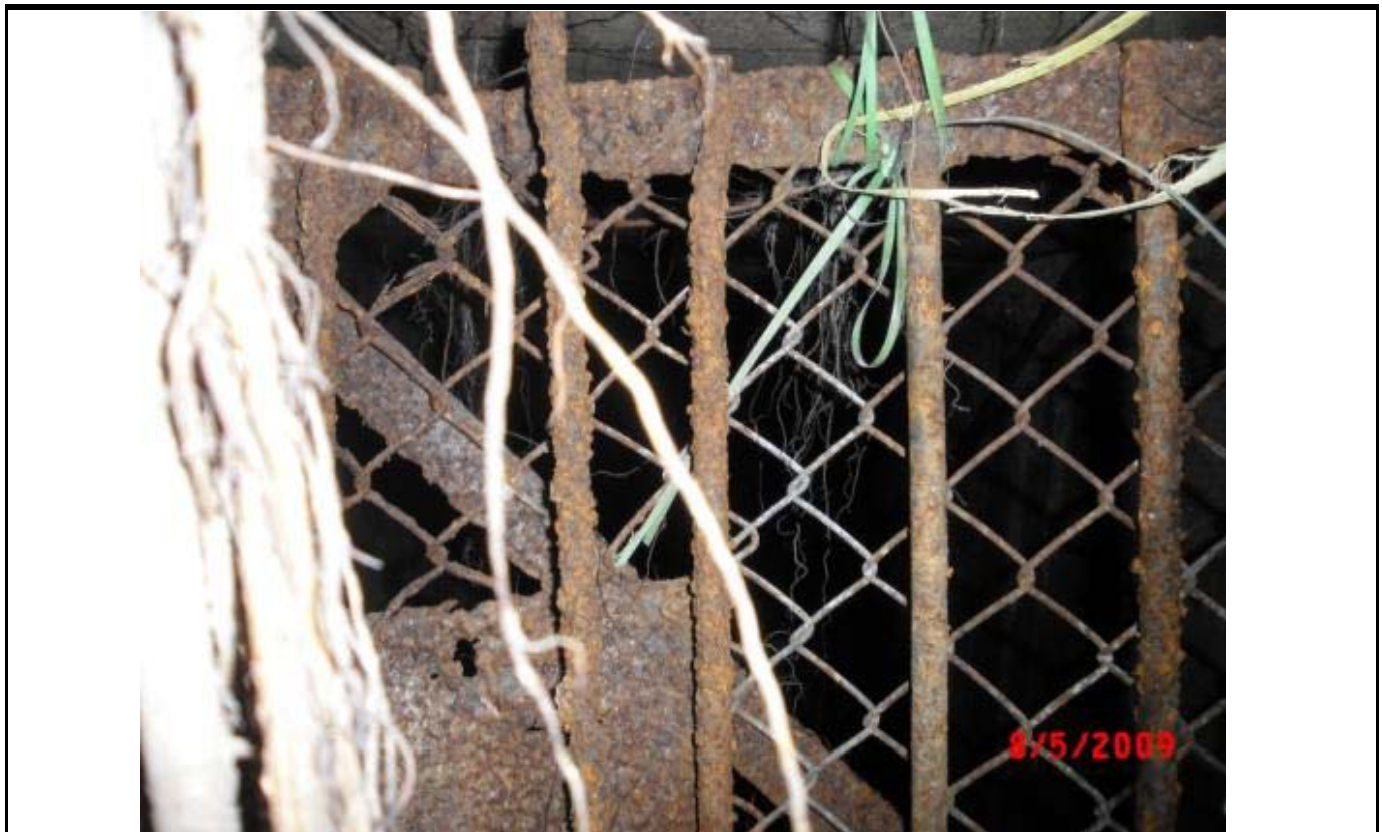
Subject Disused tunnel connected to Portal 44 (Plate 55) **Date photograph taken** 08-May-09

Description The steel gate is corroded and in poor condition

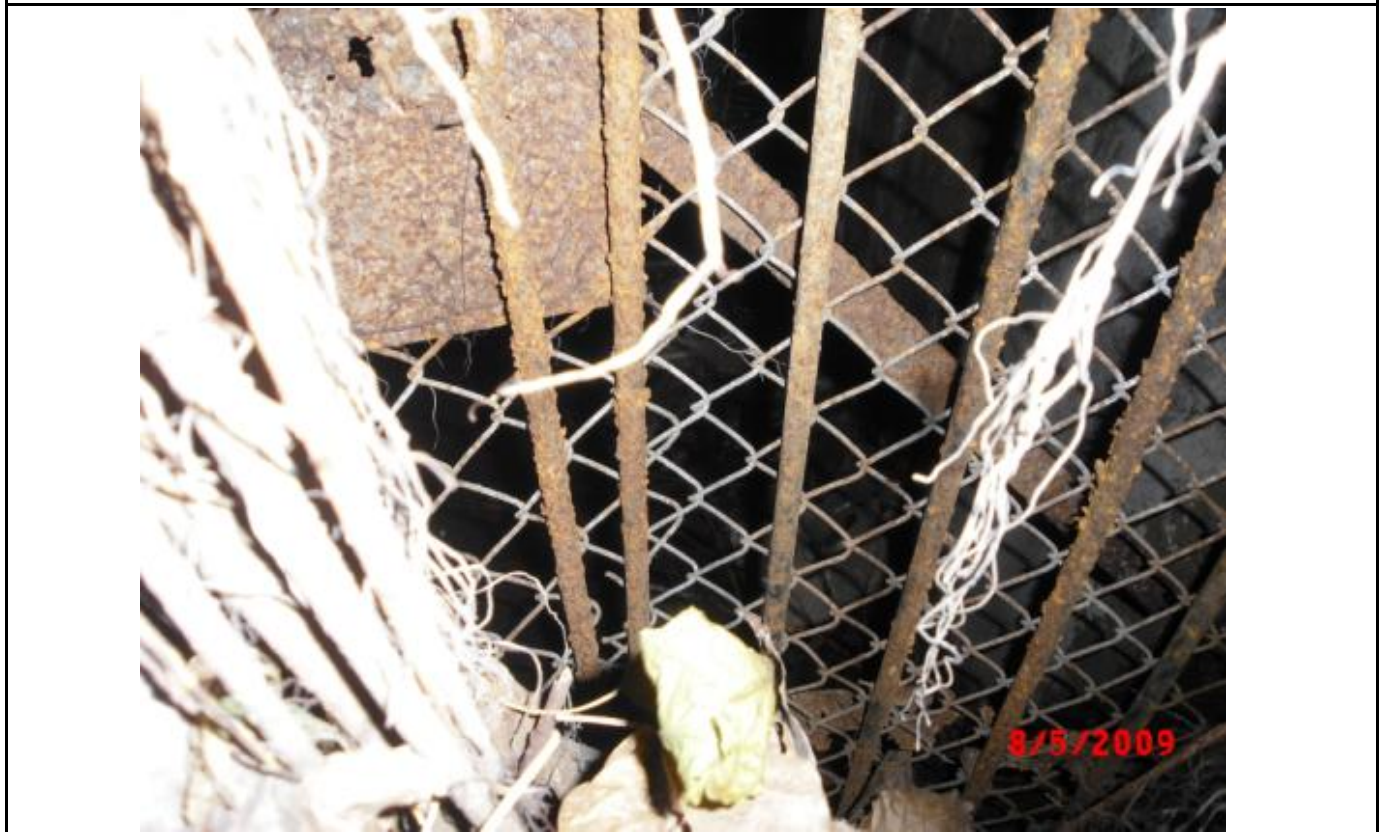
Subject Disused tunnel connected to Portal 44 (Plate 56) **Date photograph taken** 08-May-09

Description The steel gate is corroded and in poor condition

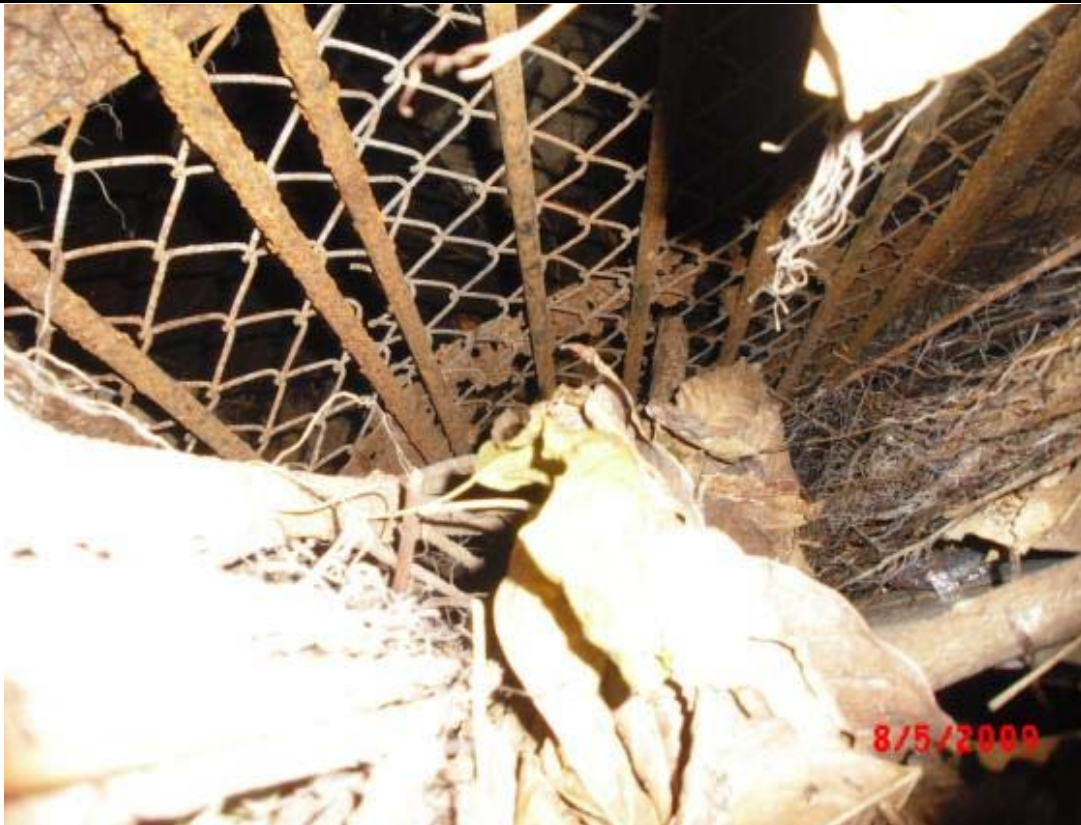
Subject Disused tunnel connected to Portal 44 (Plate 57) **Date photograph taken** 08-May-09

Description The steel gate is corroded and in poor condition

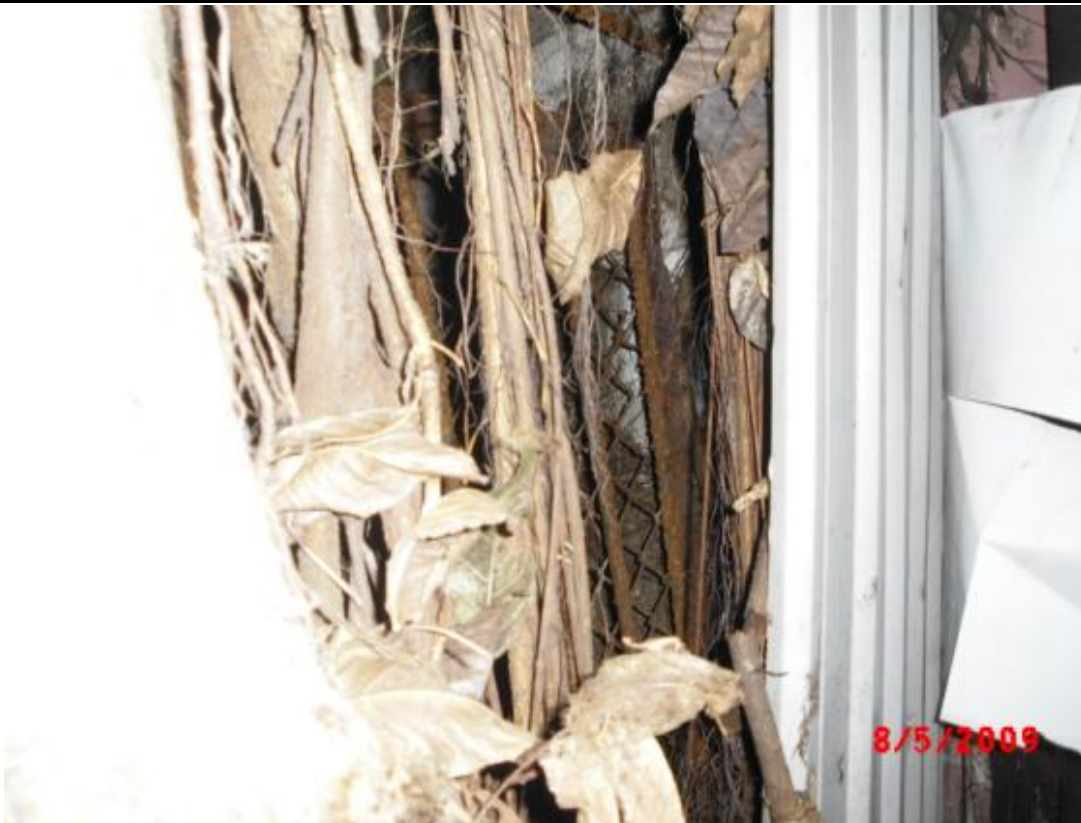
Subject Disused tunnel connected to Portal 44 (Plate 58) **Date photograph taken** 08-May-09

Description The entrance of th tunnel is blocked by tree roots

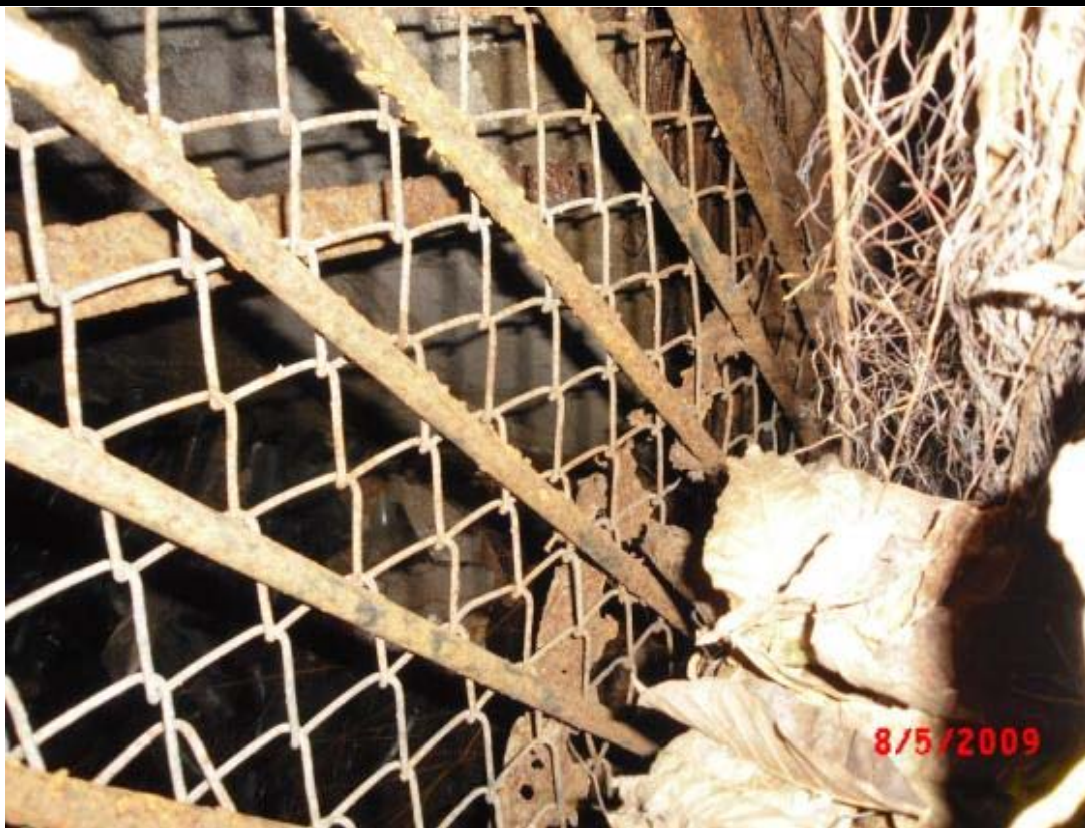
Subject Disused tunnel connected to Portal 44 (Plate 59) **Date photograph taken** 08-May-09

Description The steel gate is corroded and in poor condition

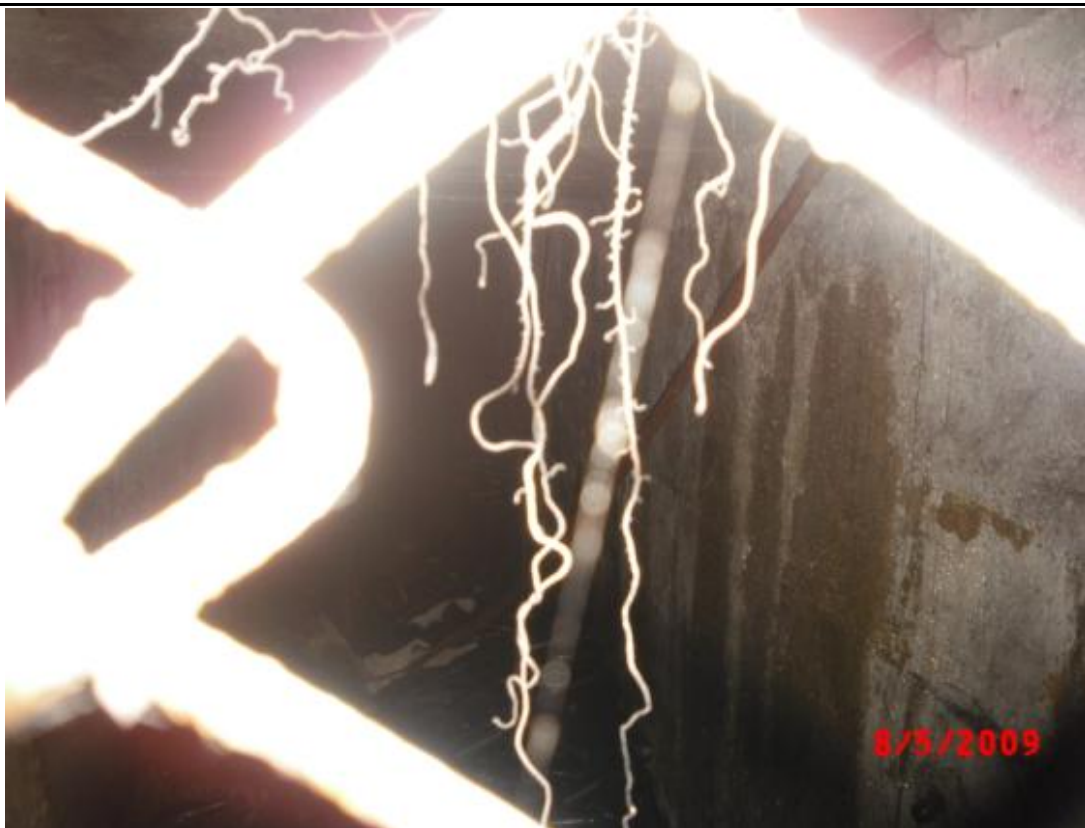
Subject Disused tunnel connected to Portal 44 (Plate 60) **Date photograph taken** 08-May-09

Description Tree roots are growing inside the tunnel
